Re: Focused Groundwater and Soil Gas Investigation
 Glendale-Ross Neighborhood / Near-Northeast Franklin
 Franklin, Indiana

EnviroForensics has conducted a focused groundwater and soil gas investigation in the neighborhood south of the former Amphenol Corporation facility (EPA ID# IND 044 587 848) near the intersection of Hamilton Avenue and Forsythe Avenue, and in the Glendale Drive neighborhood. This report documents the activities conducted during the investigation and presents our findings regarding subsurface environmental conditions in the area of potential concern.

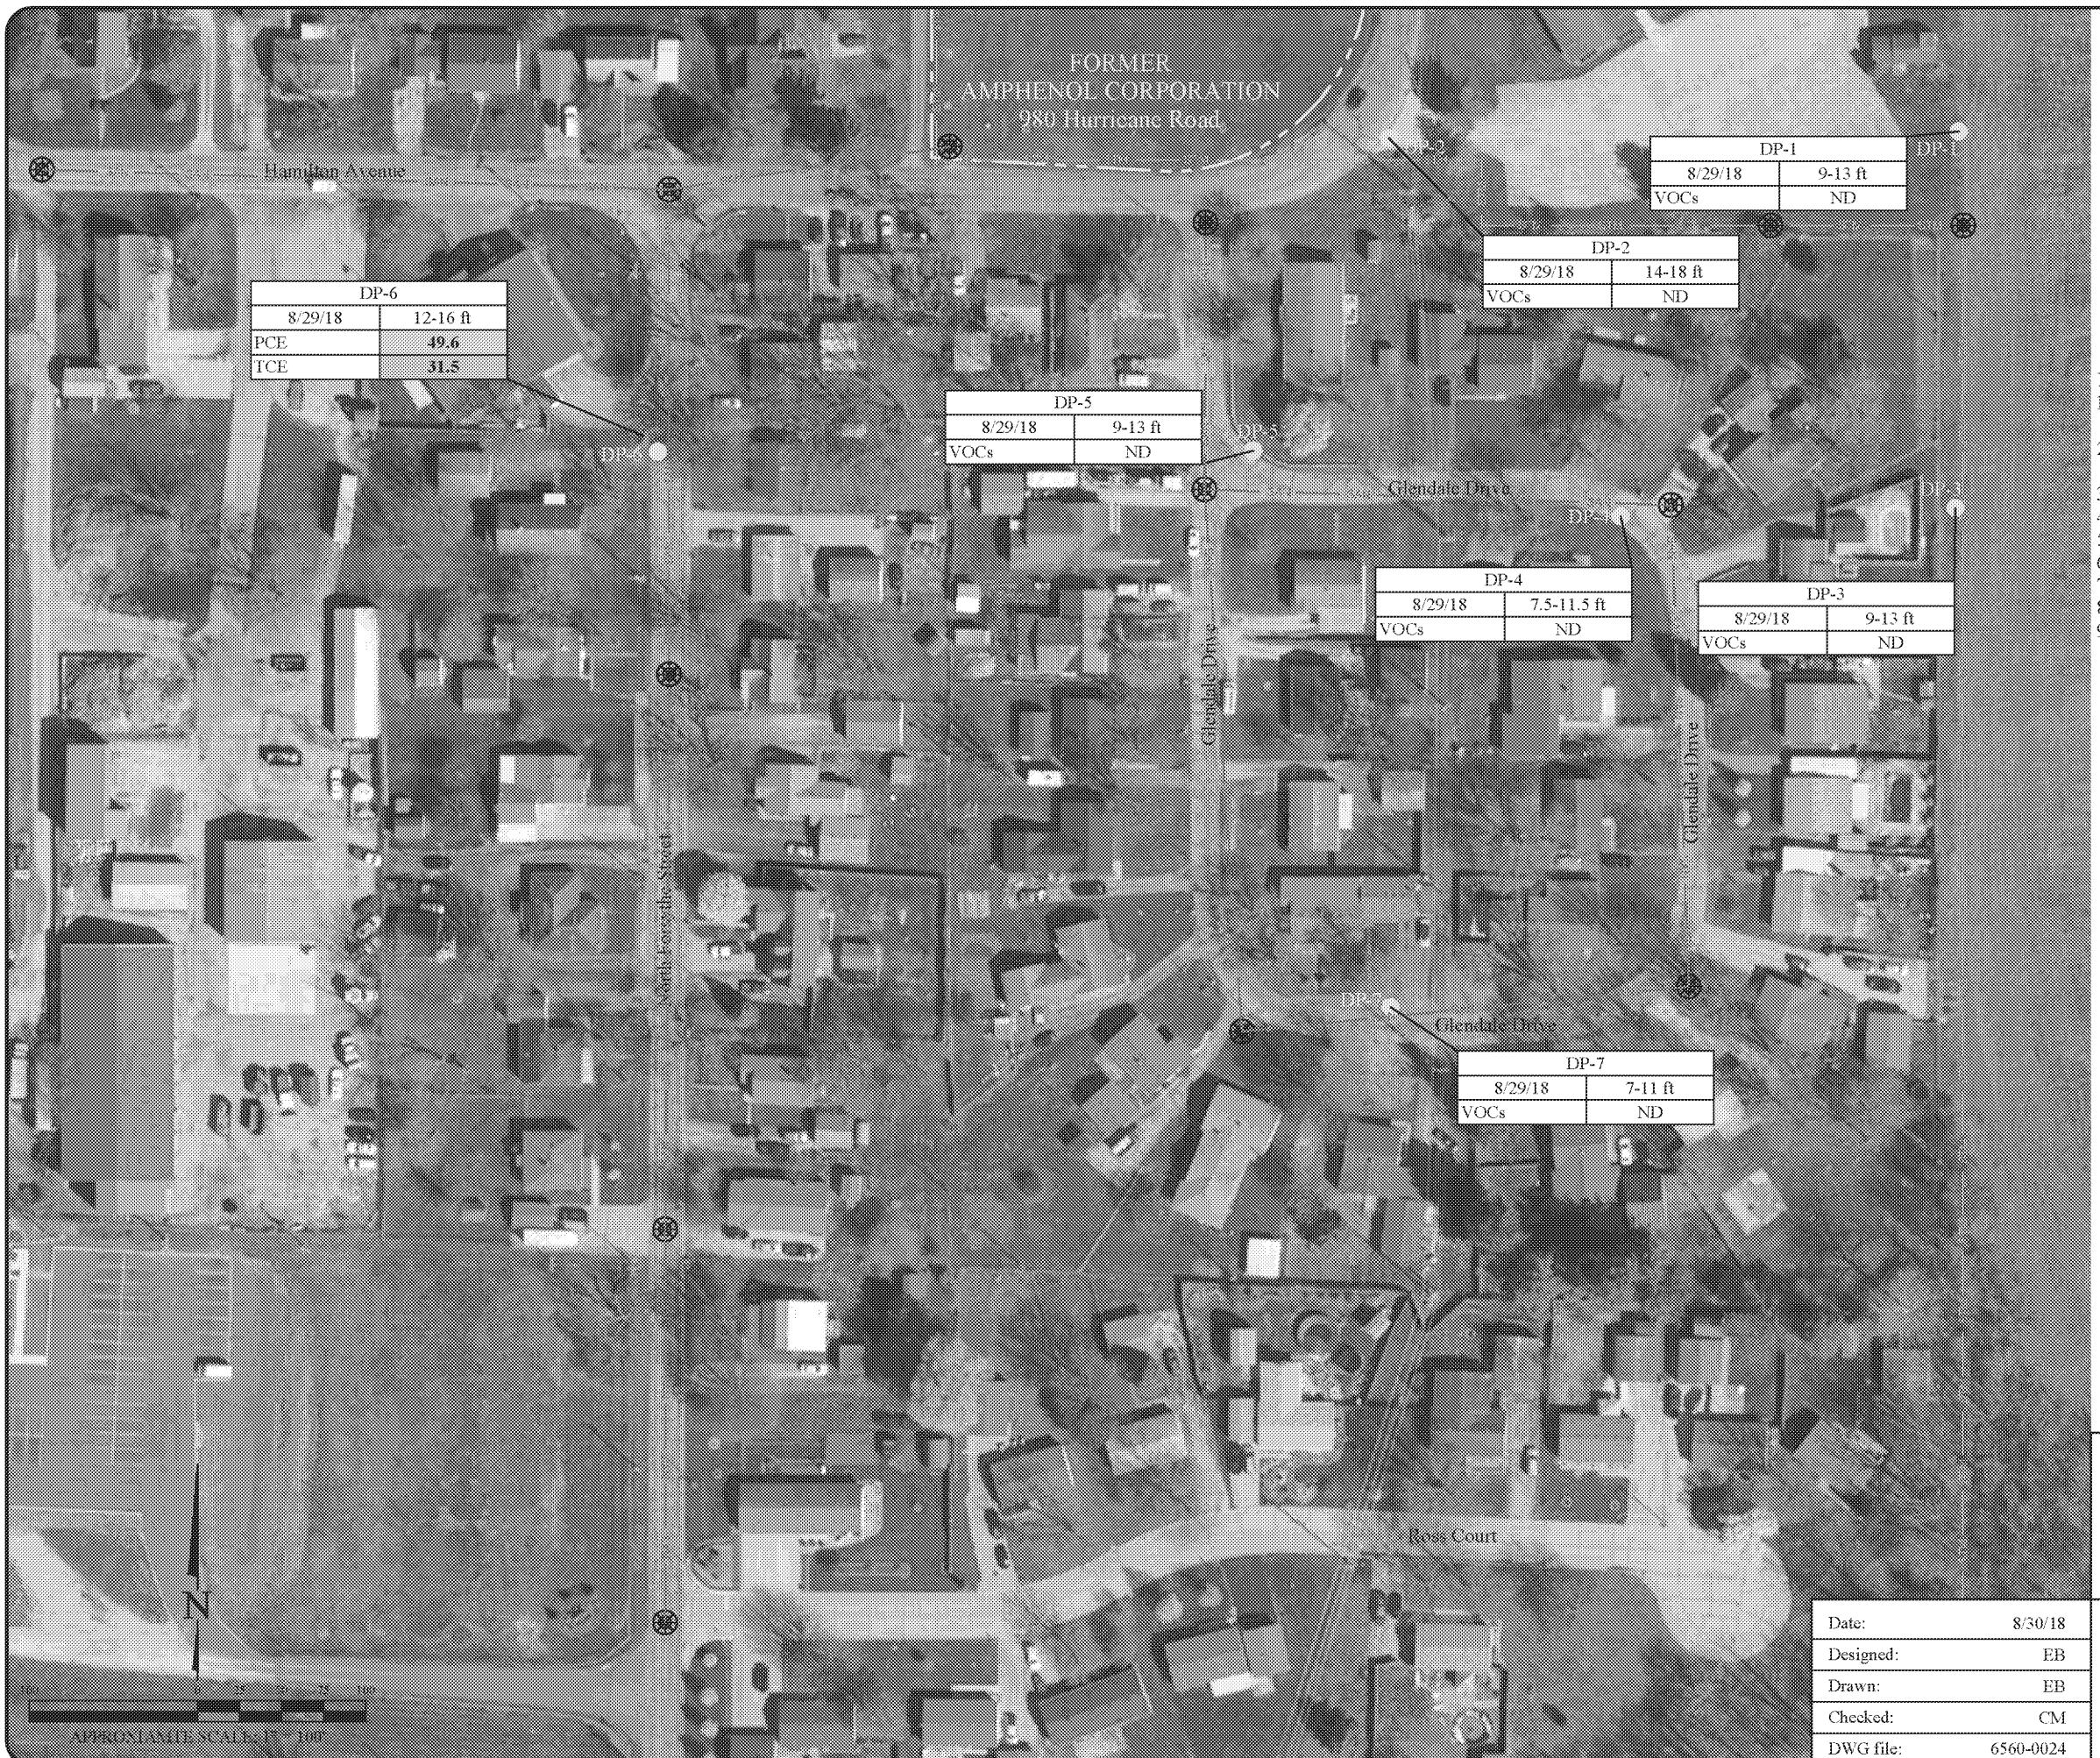
| Figure 1 | Grab Groundwater Analytical Results |

The groundwater sample collected from DP-6 contained tetrachloroethene (PCE) at a concentration of 49.6 micrograms per liter ($\mu\text{g}/\text{L}$) and trichloroethene (TCE) at a concentration of 31.5 $\mu\text{g}/\text{L}$, which exceed the IDEM RCG Ground Water Tap Screening Levels (GWSL) of 5 $\mu\text{g}/\text{L}$ for each compound. In addition, the TCE concentration in the DP-6 sample exceeded the IDEM RCG Residential Vapor Intrusion Groundwater Screening Level (VIGWSL) of 9.1 $\mu\text{g}/\text{L}$. This screening level is used by IDEM per their RCG guidance to note where vapor intrusion (VI) exposure may exist due to off-gassing from groundwater. No other VOCs were detected above laboratory detection limits in the sample from DP-6.

No VOCs were detected above laboratory reporting limits in the samples collected from DP-1, DP-2, DP-3, DP-4, DP-5 and DP-7. The groundwater analytical results are summarized in **Table 1** and depicted on **Figure 1**.

Additional Direct Push Borings - Additional direct push borings are needed to delineate groundwater impacts observed at DP-6 and determine if and where groundwater concentrations exceed IDEM RCG VIGWSLs. Borings, along with soil and grab groundwater samples, are warranted to the west, south, and east of DP-6.

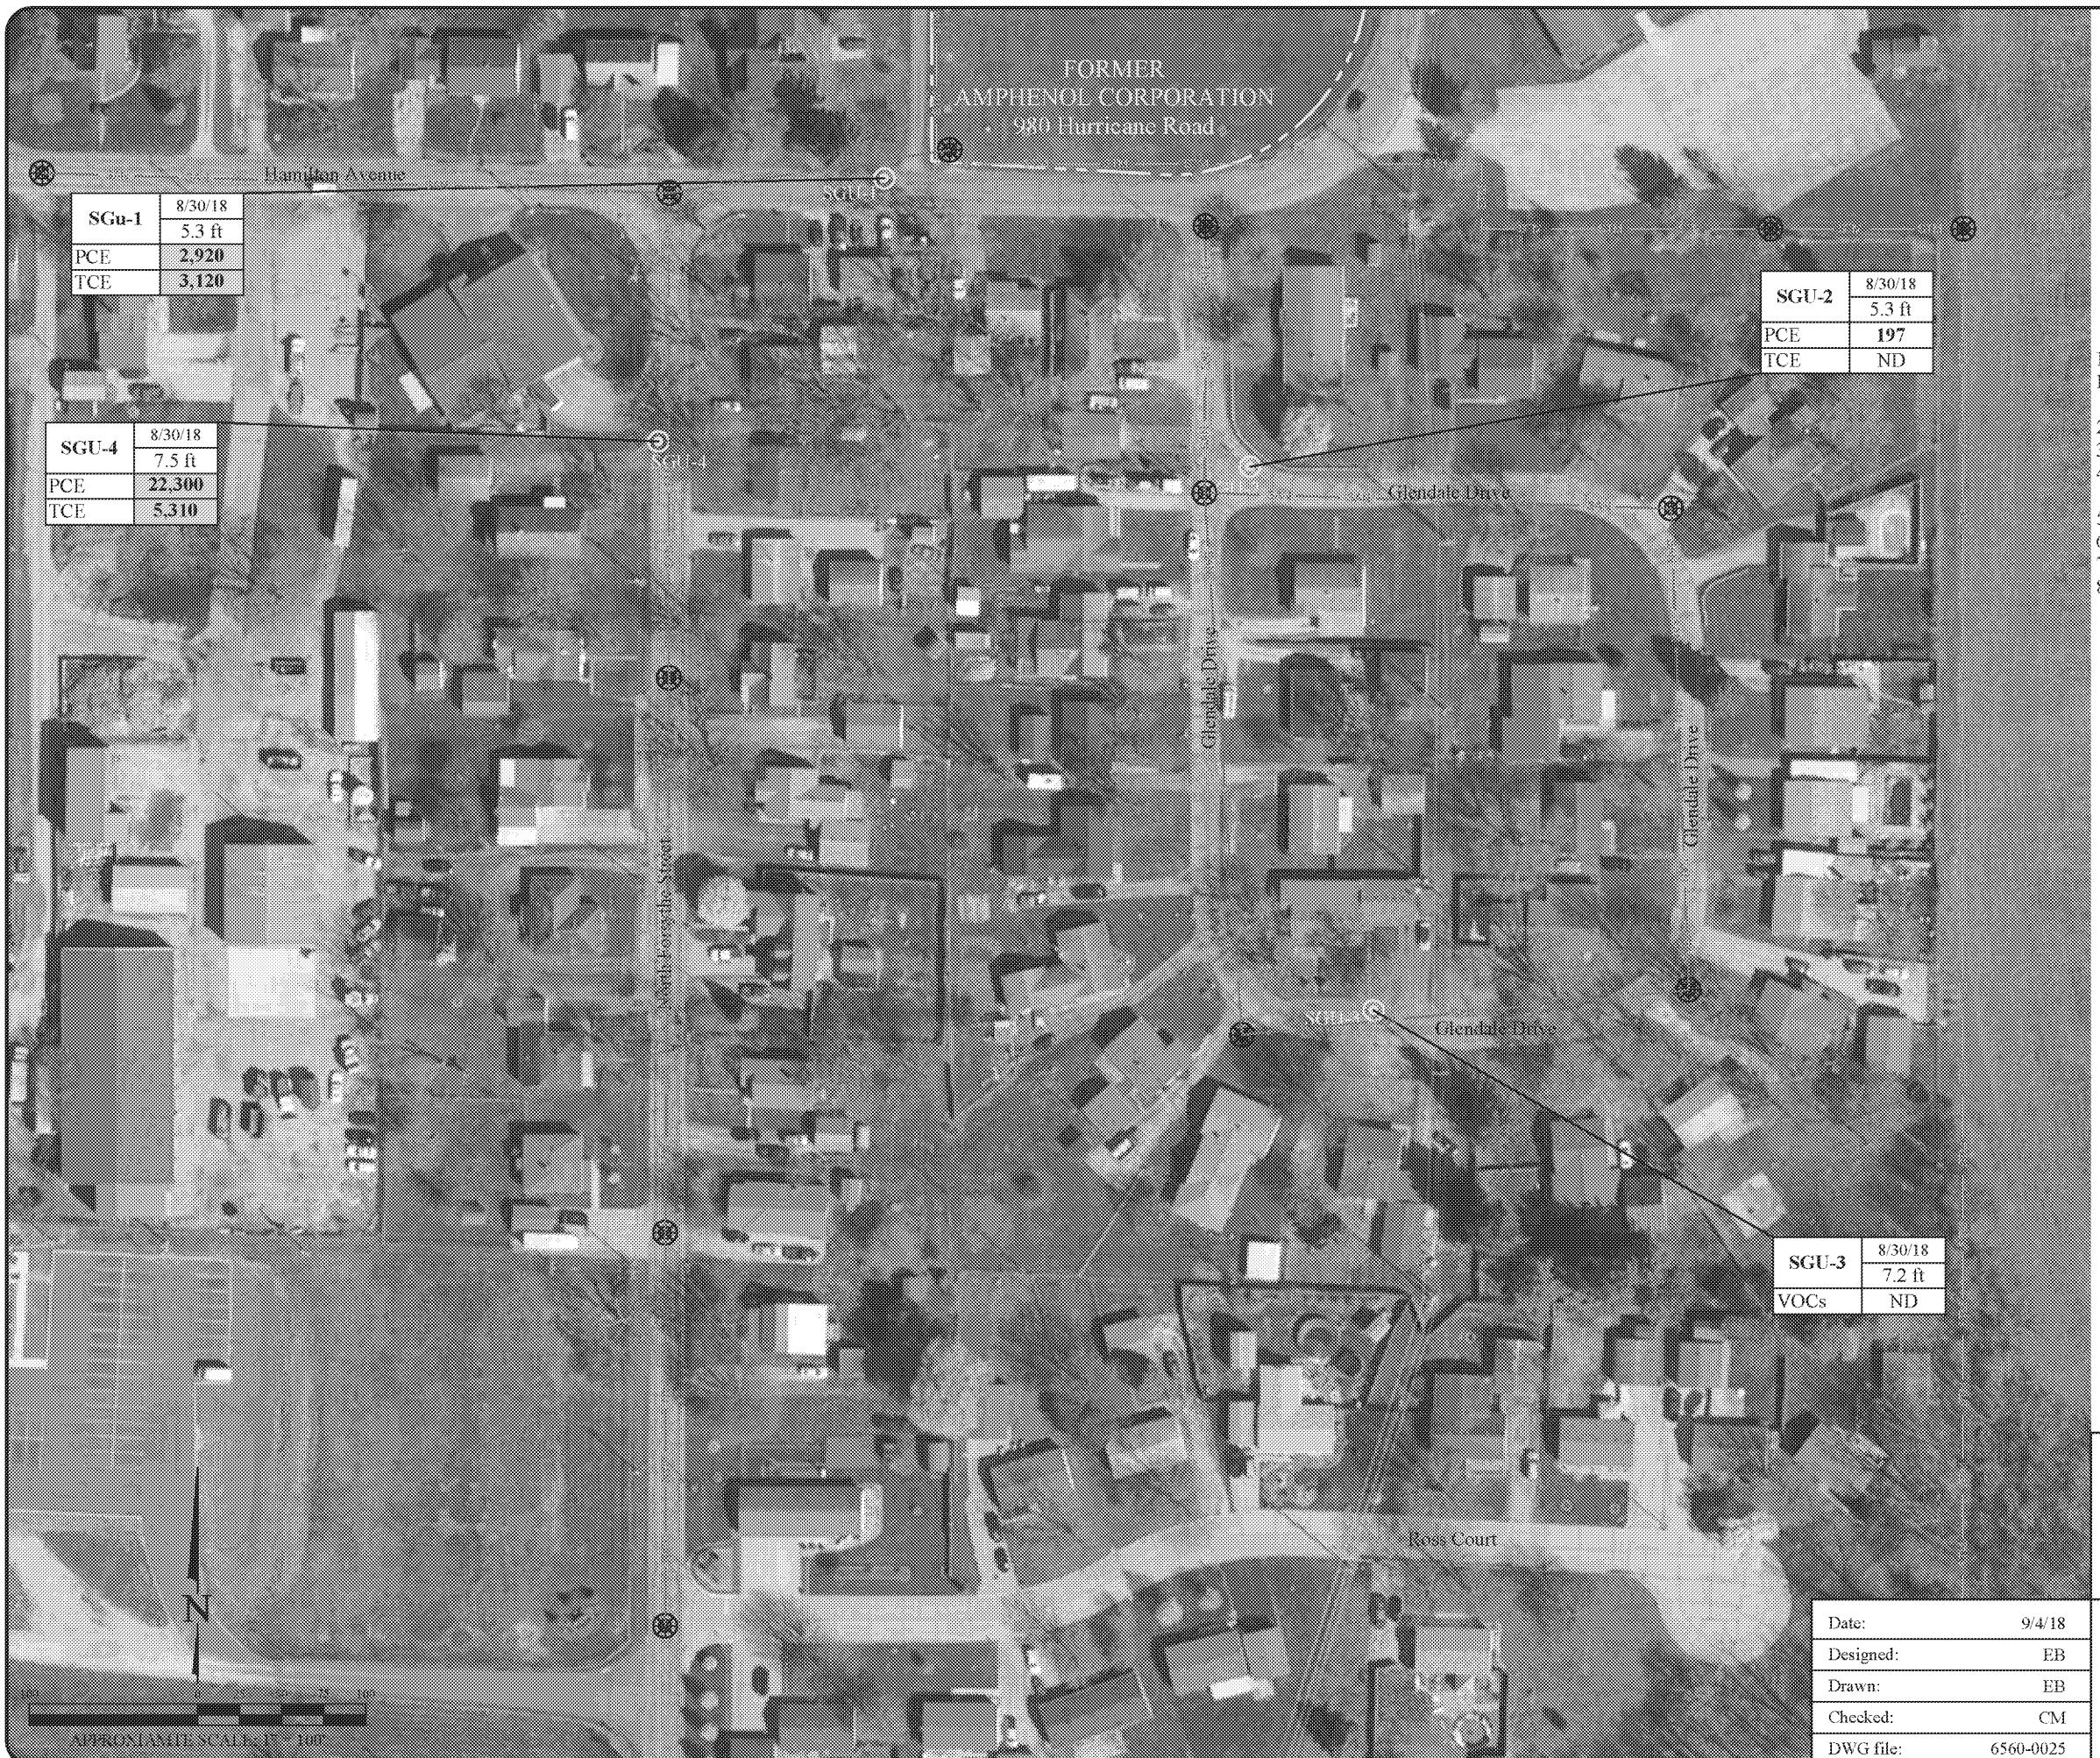
Figure
2
Project
6560

Sewer backfill vapor samples collected from SGU-1 and SGU-4 contained PCE at concentrations of 2,920 micrograms per cubic meter ($\mu\text{g}/\text{m}^3$) and 22,300 $\mu\text{g}/\text{m}^3$, respectively. These concentrations exceed the IDEM Residential Soil Gas Screening Level (SGSL) of 420 micrograms per cubic meter ($\mu\text{g}/\text{m}^3$). PCE was also detected at 197 $\mu\text{g}/\text{m}^3$ in the sample collected from SGU-2 along northern Glendale Drive, but this concentration is below the IDEM Residential SGSL. PCE was not detected in the soil gas sample collected from SGU-3 along southern Glendale Drive.

The sewer backfill vapor samples from SGU-1 and SGU-4 also contained TCE at concentrations of 3,120 $\mu\text{g}/\text{m}^3$ and 5,130 $\mu\text{g}/\text{m}^3$, respectively. These concentrations exceed the IDEM SGSL of 21 $\mu\text{g}/\text{m}^3$.

TCE was not detected in the sewer backfill vapor samples collected from Glendale Drive, SGU-2 and SGU-3.

Note that chloroform and m, p-xylene were also detected in the sewer backfill vapor sample collected from SGU-4. Chloroform was detected at a concentration of 14.6 $\mu\text{g}/\text{m}^3$, which exceeds the IDEM Residential SGSL of 12 micrograms per cubic meter ($\mu\text{g}/\text{m}^3$). Xylene was detected at a concentration of 462 $\mu\text{g}/\text{m}^3$, which is below the IDEM Residential SGSL of 1,000 $\mu\text{g}/\text{m}^3$. Chloroform and xylene were not detected in sewer backfill vapor samples collected from SGU-1, SGU-2, and SGU-3.

The sewer backfill vapor analytical results are summarized in **Table 2** and depicted on **Figure 2**.

Soil Gas Sample Collection Within Sanitary Sewer Backfill - The extent of soil gas contaminants within the underground sanitary sewer corridor has not been defined. The collection of additional soil gas samples within the sanitary sewer backfill to the south along Forsythe Street, to the west along Hamilton Avenue, and on Glendale Drive is warranted.

Sewer Air Sample Collection Within Sanitary Sewer Manholes - Contaminant vapors can travel through existing sewer pipes as well as through the surrounding backfill. The collection of grab sewer air samples within manholes along Forsythe Street, Hamilton Avenue, and Glendale Drive is warranted to determine if this is a potential exposure pathway.
